XII FIP Congress
Washington, D.C., USA/ May 29-June 2, 1994.

Borislav T. Tomasevic, B.Civ.Eng.*

EXAMPLES FOR BEHAVIOR OF PRESTRESSED CONCRETE STRUCTURES EXPOSED
TO IMPACT LOADING IN THE STAGE OF CONSTRUCTION AND WAY OF
REPAIRING DAMAGED STRUCTURAL ELEMENTS

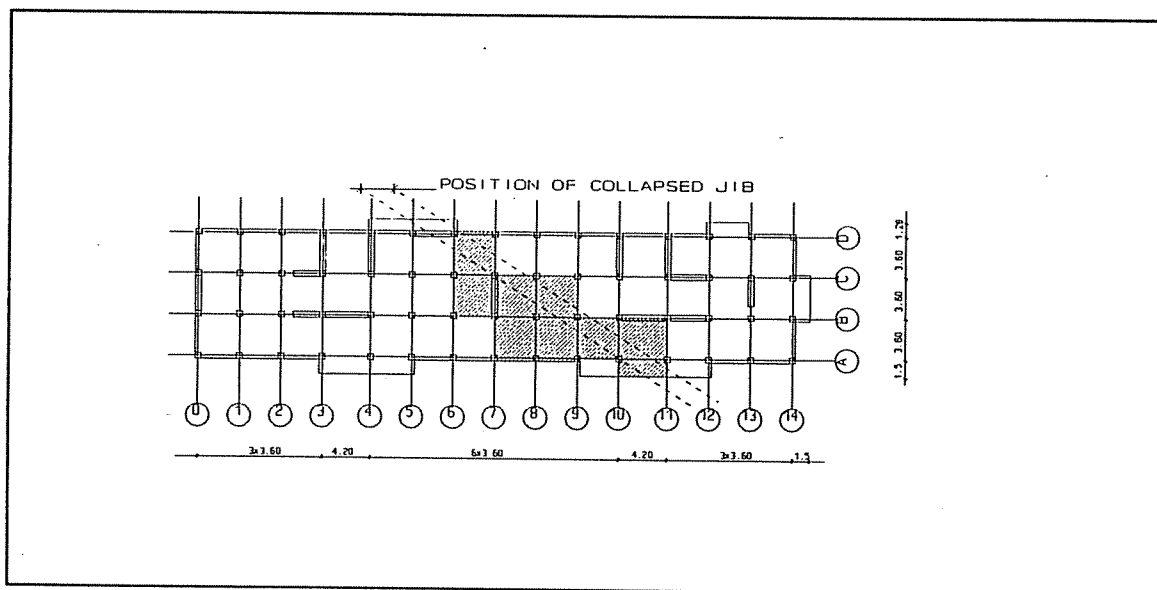
Figure 1. Layout of the damaged structural elements

The collapse of the jib caused the damages of the structural elements at the level above the ground floor, shaded in Figure 1. The IMS Institute's associates, called by the contractor, carried out all the necessary surveyings of the damages. Individual damages are presented in detail in a separate paper /3/, while this paper gives only a global review of the types of damages.

In the case of ordinary floor-slabs, the damages range from a completely wrecked floor-slab in the B-C/7-8 span to slightly scratched edge ribs, while the cantilever floor-slab in the A/10-11 span was completely destroyed.

The edge girders (D/5-6 and D/6-7) were displaced from the spot of incorporation, since they were directly hit by the jib.

The damages on the columns include "chipped" column heads on the contact with the above-mentioned damaged structural elements and the cracks on the D/11 column head, while the vertical line of the columns in both orthogonal directions was preserved even after the jib's collapse.

Precast shear wall in the 7/B-C axis was displaced from the vertical line, but it was not wrecked, since at the moment of the jib's collapse the bottom anchors were welded, while the upper ones were inserted among the tendons.

The only exception from the adopted repairing concept is the completely destroyed cantilever floor-slab in the A/10-11 span, which is replaced by a new precast floor-slab in the standard way, with preliminary cutting and replacement of one tendon 6 ϕ 7 in each of the axes 10 and 11.
